Fragility curves for non-engineered masonry buildings in developing countries derived from real data based on structural surveys and laboratory tests

Viviana Iris Novelli^{1,2} · Raffaele De Risi² · Ignasio Ngoma³ · Innocent Kafodya³ · Panos Kloukinas⁴ · John Macdonald² · Katsuichiro Goda⁵

Accepted: 15 January 2021 / Published online: 18 February 2021

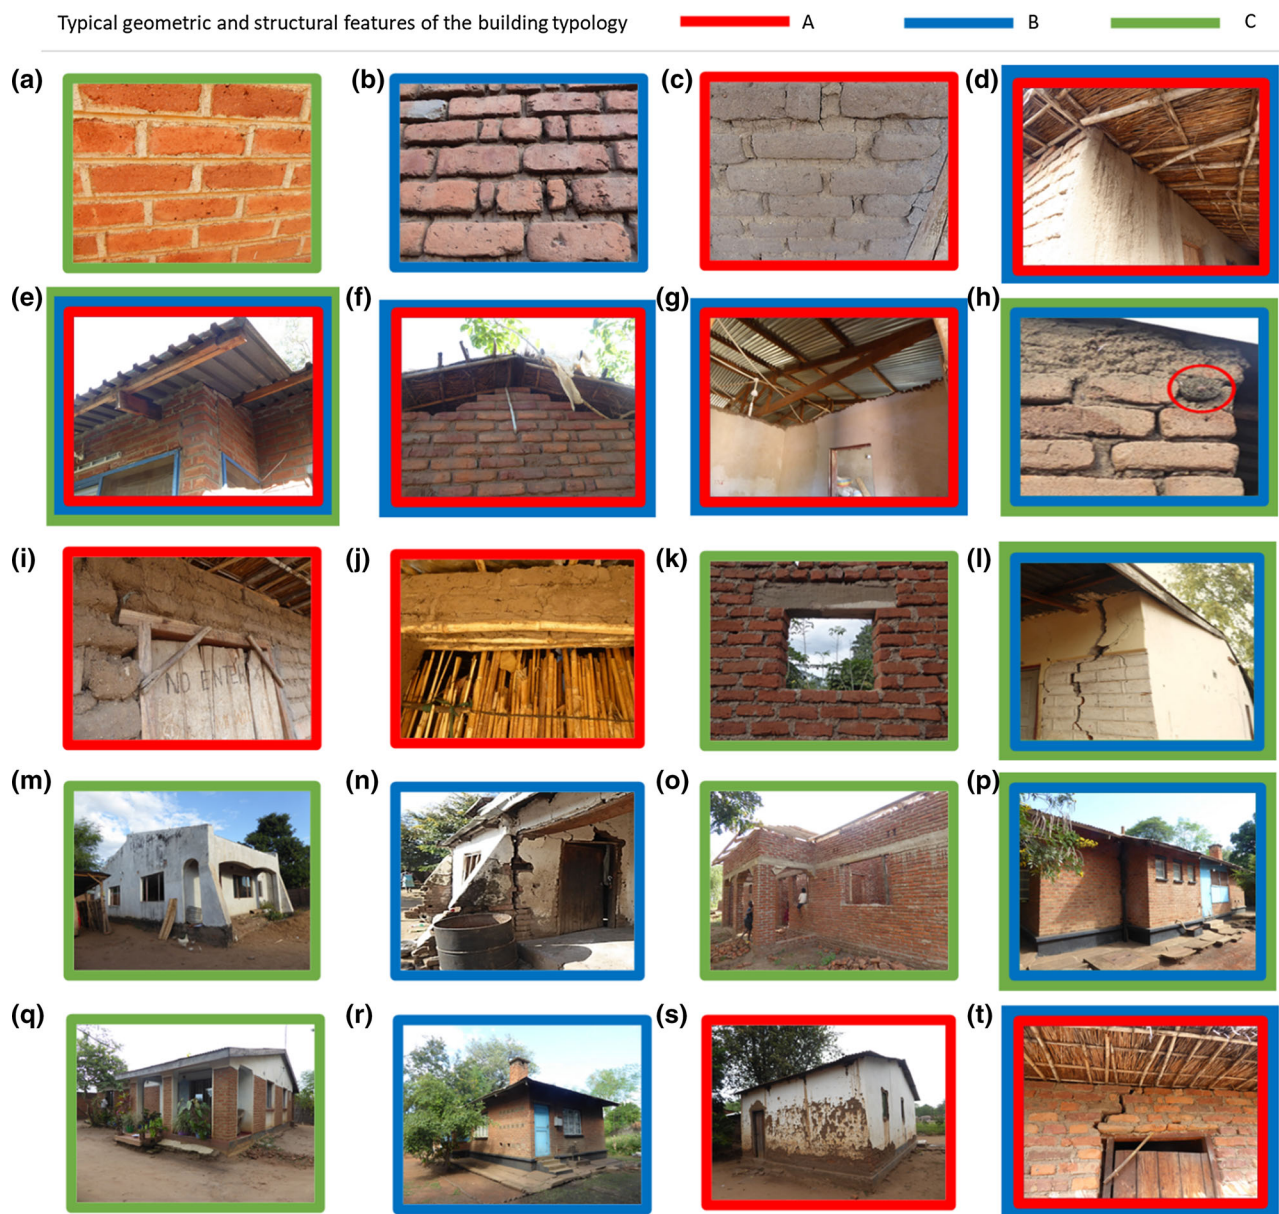
Fig. 6 Typical buildings in Malawi: **a** fired bricks with cement mortar; **b** fired bricks with mud mortar; **c** unfired bricks with mud mortar; **d** thatched roof; **e** light metallic sheets; **f** gable detached from the roof structure; **g** lack of connection between walls and roof system; **h** timber wall plates of circular section; **i** door frame showing absence of lintels; **j** bamboo lintel; **k** concrete lintel; **l** house with poor

connection between walls; **m** new constructions with buttresses; **n** lack of connection between buttress and wall; **o** concrete ring beam; **p** re-entrant corner; **q** portico; **r** chimney; **s** material erosion; **t** typical cracks. The red-blue-green tag on each picture is used to highlight the geometric/structural features of the building typologies A, B, and C, introduced in Sect. 3.1.1

On-site structural surveys were carried out on 323 non-engineered unreinforced masonry buildings located in formal and informal settlements in the townships of Salima and Balaka and informal settlements of the villages Lifidzi and Golomoti (see Fig. 1b). 86% of the inspected buildings are made of fired (clay) bricks (see Fig. 6a, b), since these materials are relatively cheap to source on-site and do not need specific construction skills. The remaining 14% of the inspected buildings are made of mud bricks (see Fig. 6c), a

corrugated sheets are observed for the remaining inspected buildings (Fig. 6e). Both roof types do not act as a rigid diaphragm during an earthquake. Furthermore, roofs generally are not connected to the bearing walls; therefore, they are not able to provide restraint against lateral movements due to winds or earthquakes (Fig. 6f, g). Only occasionally, timber wall plates are used on the top of the longest external walls to support the roof structures

the roof and openings. This is evident from the presence of cracks, material erosion, dry timber rot, damaged boards, and door jams (Fig. 6s, t).

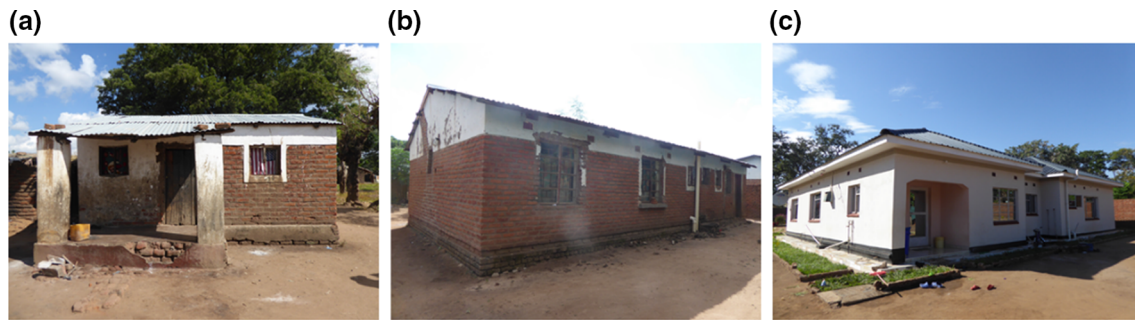
Fig. 8 Typical masonry buildings in Malawi: **a** typology A; **b** typology B; **c** typology C

unfired or fired bricks with mud mortar and are of poor fabric quality (Fig. 3b3). Generally, these houses have smaller building footprints than a typical floor plan of 8 m × 6 m. These houses have thatch or corrugated metallic sheet roofs supported by light timber elements. The structures are characterised by poor structural detailing (e.g. lack of connection between walls and between walls and roof).

- **Typology B**—This is the most common typology observed in Malawi, representing 50% of the buildings, and is rated as medium seismic vulnerability (Fig. 8b). These buildings are made of fired bricks with medium- to good-quality fabric (Fig. 3b1, b2). Due to the presence of mud mortar, bonding between bricks is considered poor; therefore, connections between walls are assumed weak. The construction details varied significantly as well as maintenance levels.
